COMMON PATHOLOGIES IN URINARY SYSTEM AND SIGNS ASSOCIATED WITH THEM

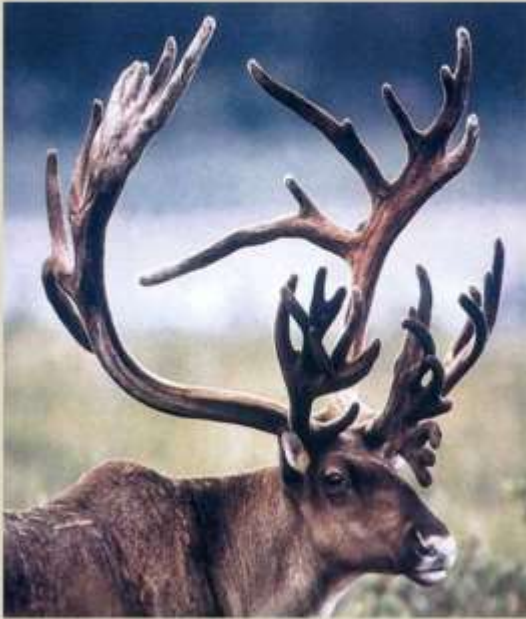
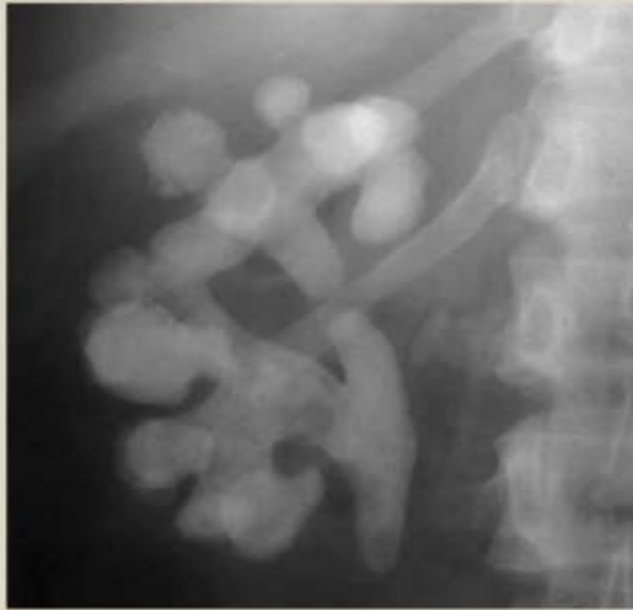
(a) Staghorns. (b) On a scout image obtained before excretory urography, a calculus fills nearly the entirety of a bifid right renal collecting system, giving it a branched appearance that resembles the antlers of a stag

Staghorn calculi, also sometimes called **coral calculi**, are renal calculi that obtain their characteristic shape by forming a cast of the **renal pelvis** and calyces, thus resembling the horns of a stag.

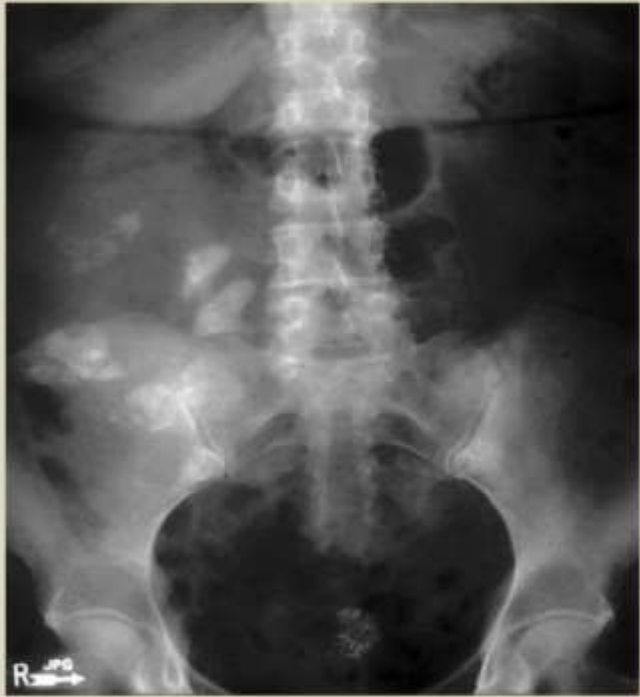
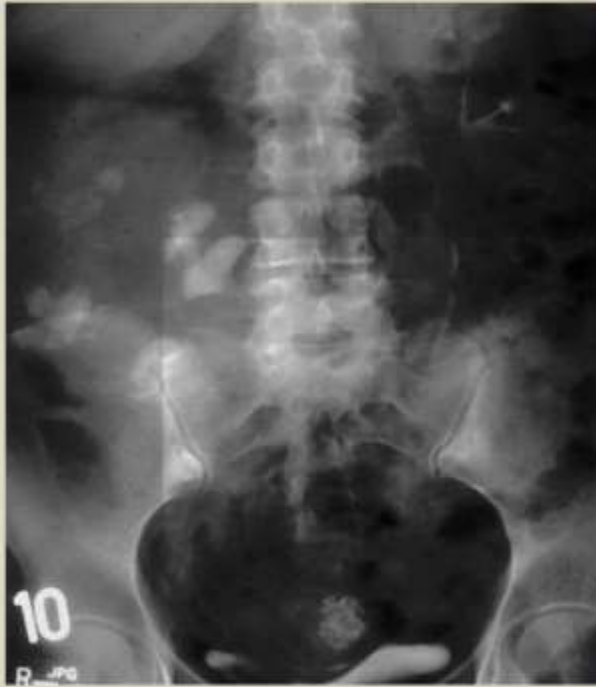
a) Scout radiograph obtained before excretory urography demonstrates disruption of the elements of a staghorn calculus—a fragmented staghorn—in an enlarged right kidney. (b) Excretory urogram shows no evidence of contrast material excretion from the right kidney. Renal enlargement, presence of an obstructing stone, and absence of excretion are considered the classic imaging triad of xanthogranulomatous pyelonephritis.

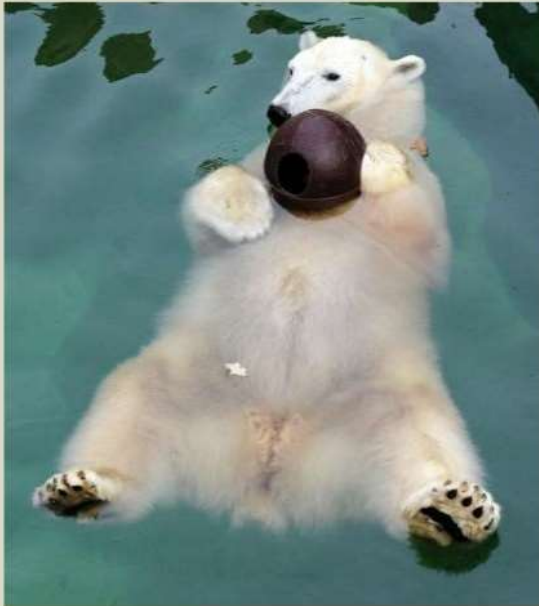
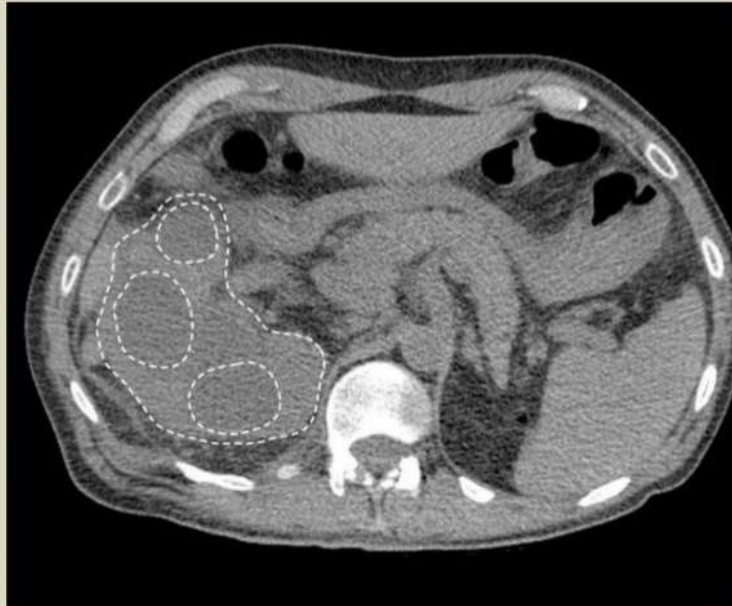
Bear paw sign

The **bear paw sign** is seen in xanthogranulomatous pyelonephritis and refers to the cross-sectional appearance of the kidney which is said to resemble the paw of a bear. The renal pelvis is contracted whereas the calyces are dilated, mimicking the toe-pads of the paw.

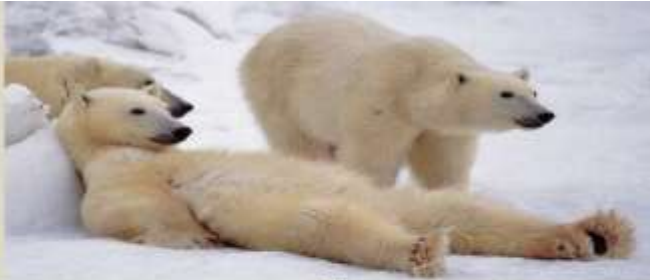
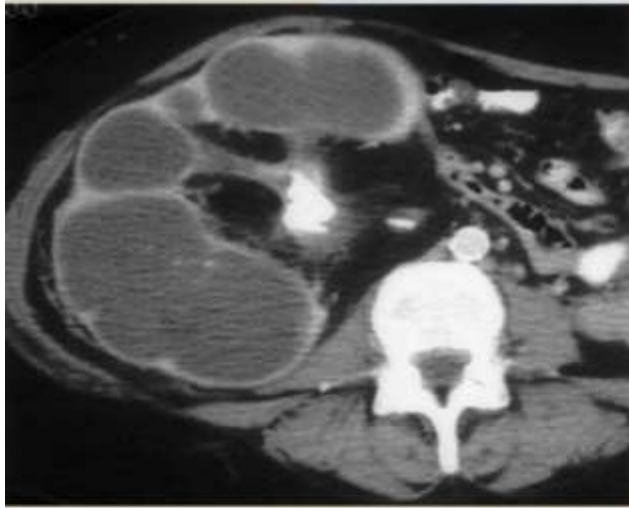
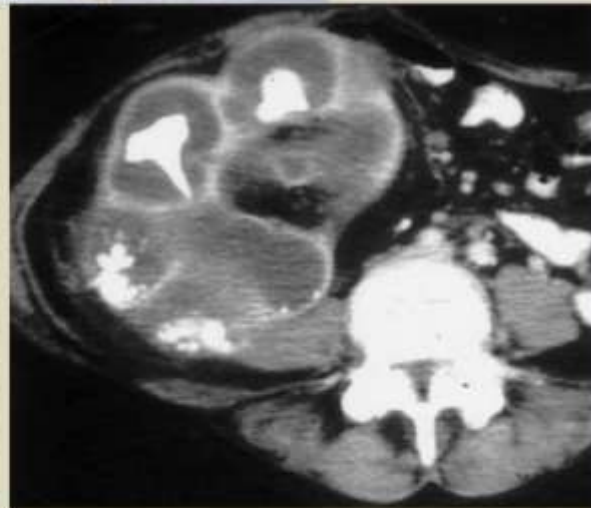
(a) A bear's paws. (Photograph entitled "Bad Boys of the Arctic" reprinted with permission from Thomas D. Mangelsen, Inc.) (b) Contrast material-enhanced CT scan (same patient as in Fig 2) demonstrates a centrally obstructing stone with replacement of the renal parenchyma by low-attenuation collections in a "hydronephrotic" pattern. Note the lack of dilatation of the renal pelvis and infundibula. (c) CT scan obtained at a slightly lower level shows the fragments of a staghorn calculus within the parenchymal collections, which exhibit marginal enhancement. The pattern seen at CT resembles a bear's paw

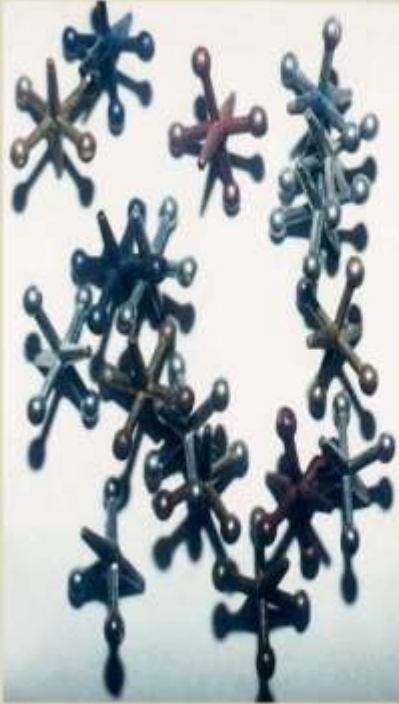
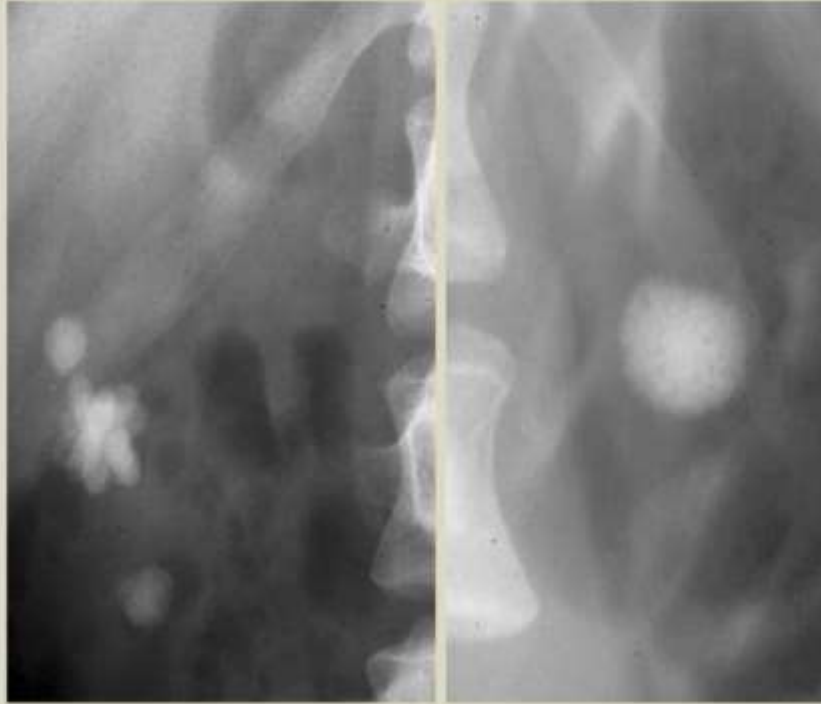
(4a) Jacks. (4b) Scout radiograph shows a jack stone with long spikes that has formed within the kidney. (5) Scout radiograph of a mulberry stone shows its less well-developed spikes, which give it a mamillated appearance, resembling a mulberry.

Jackstone calculus is the name assigned to the appearances of a sub-set of urinary tract calculi.

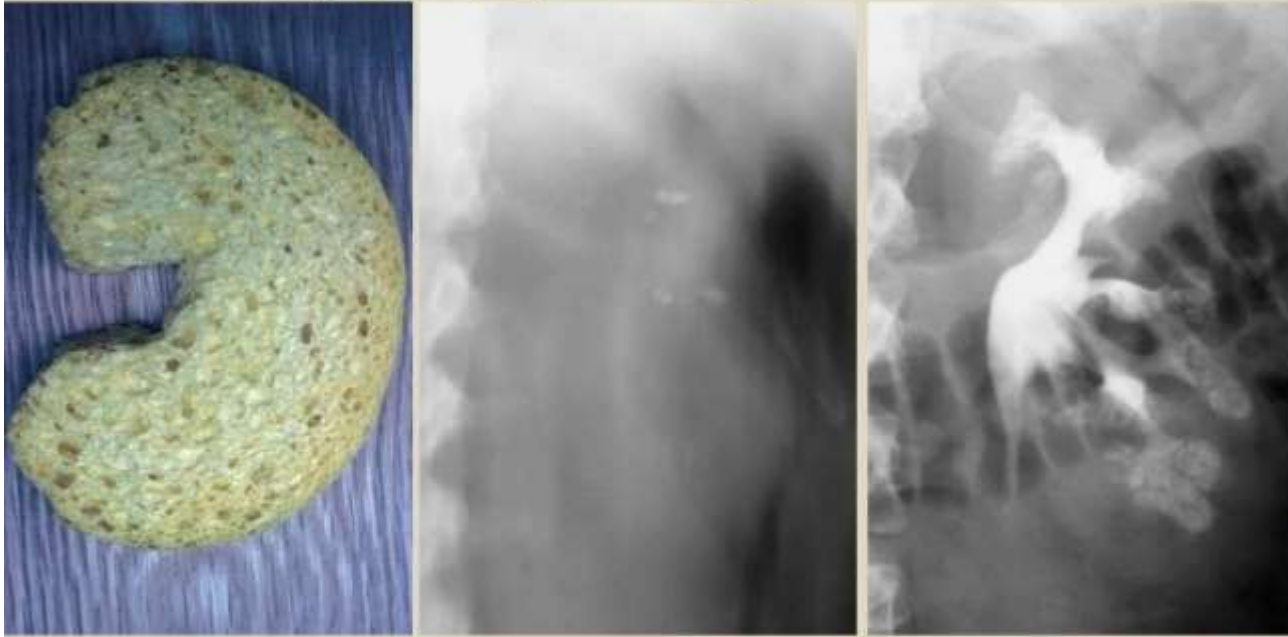
(a) "Sponge" kidney, made from a sponge! (b) Scout image from excretory urography demonstrates calcifications clustered in the medullary portion of the left kidney. (c) After contrast material administration, numerous cavities are identified within the renal papilla in the patient with medullary sponge kidney. Some of the calcifications appear to grow, as contrast agent fills the entire cavity containing the stone.

Medullary sponge kidney (MSK) is a sporadic condition where the medullary and papillary portions of the collecting ducts are dysplastic, and dilated and in most cases develop medullary nephrocalcinosis.

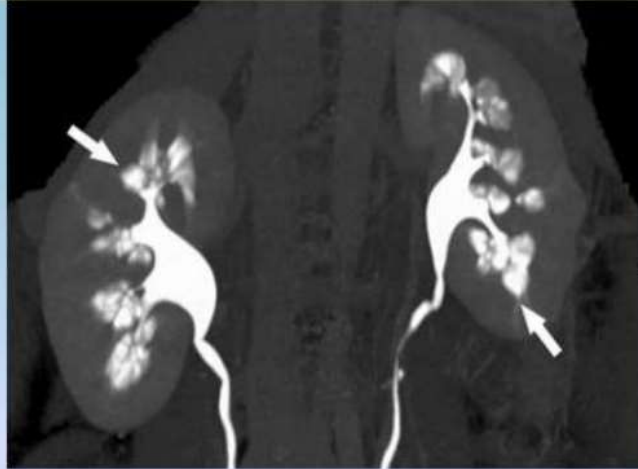
CT - Numerous cavities with calcifications within renal papilla.

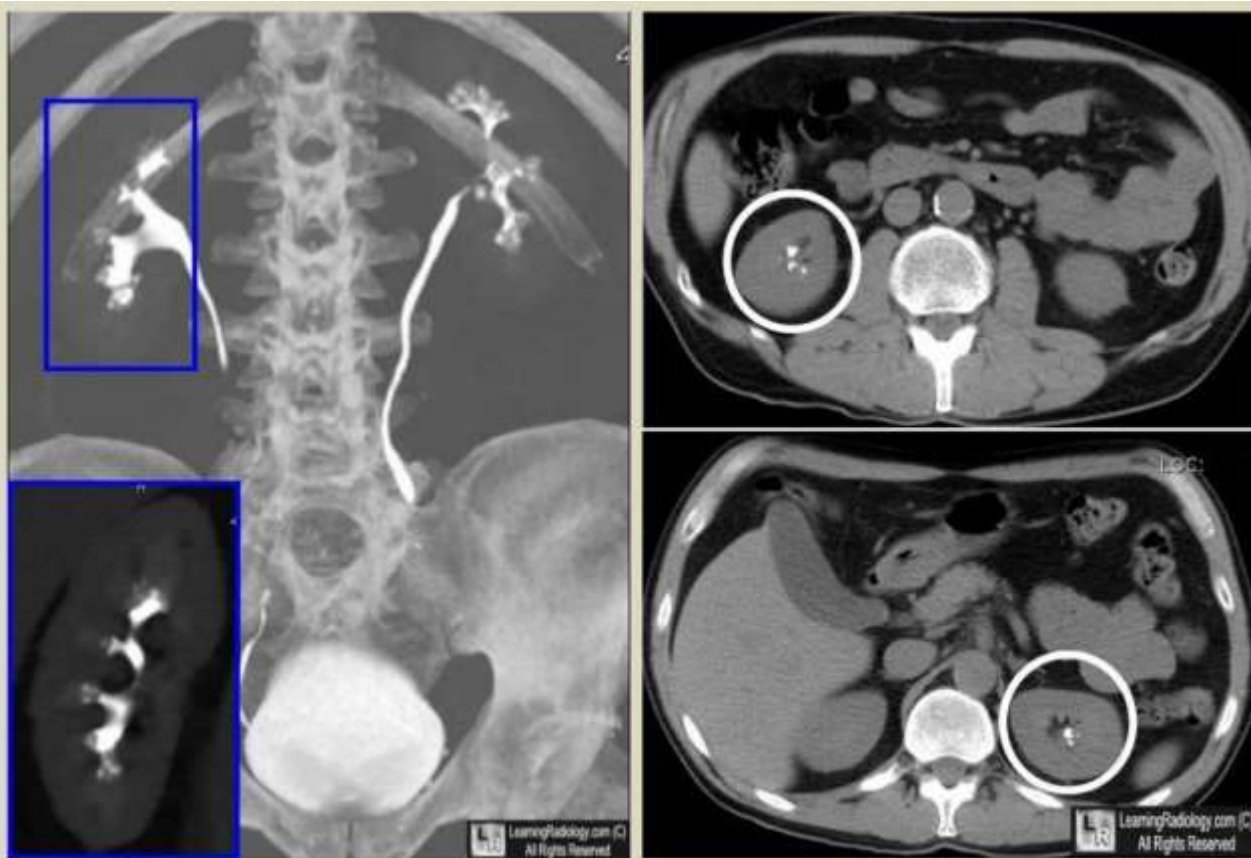
Medullary Sponge Kidneys with Calculi.

Term applied to the development of ectatic tubules occurring in medullary pyramids.

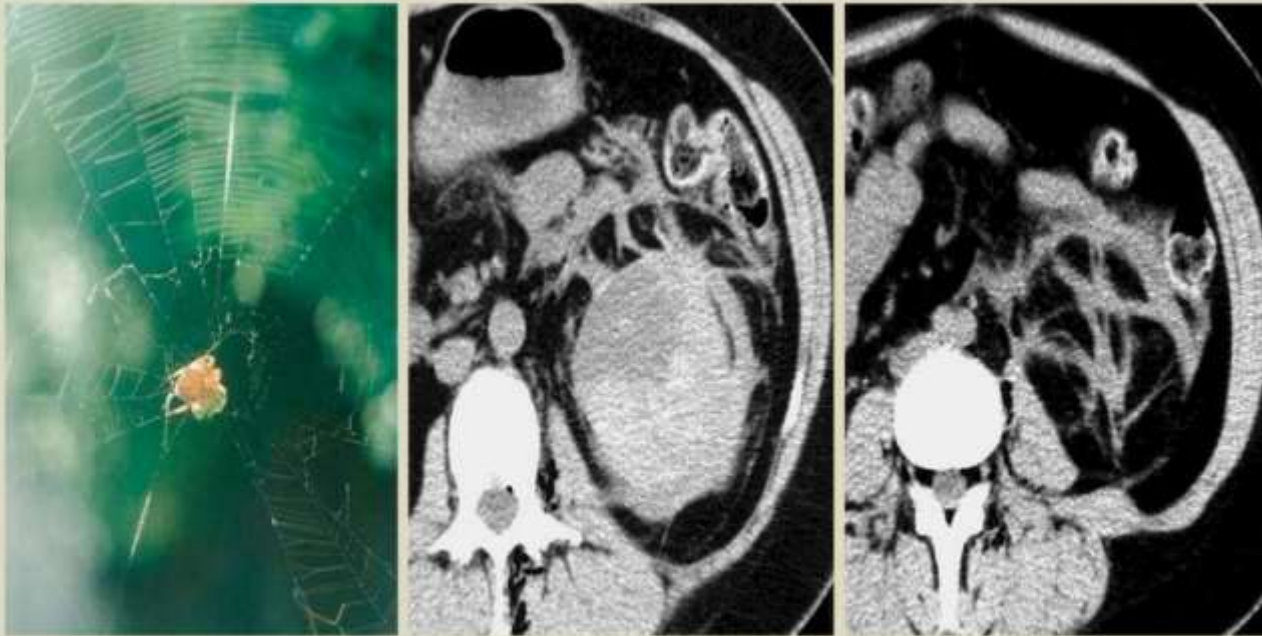
(a) Cobwebs. (b) CT scan obtained after extracorporeal lithotripsy reveals a subcapsular hematoma and exaggeration of Kunin septa on the left. Reno-fascial and reno-renal septa are especially well identified. (c) On another CT scan obtained at the lower aspect of the left kidney, fascio-fascial septa are nicely seen, and the cobweb appearance is particularly well developed

Peri-renal cobwebs is the presence of prominent perinephric septae. It is best appreciated on CT images.

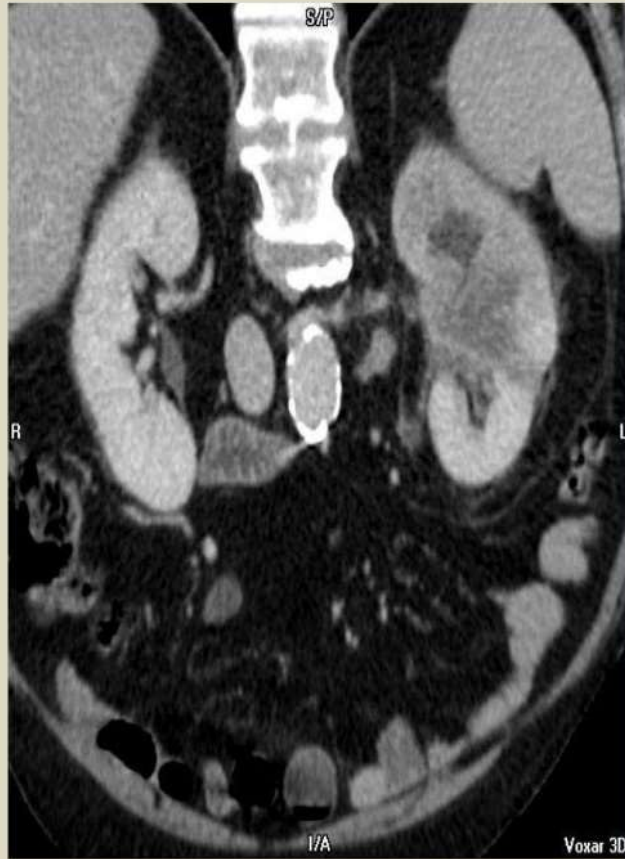
Transitional cell carcinoma of the renal pelvis with Peri-renal cobweb.

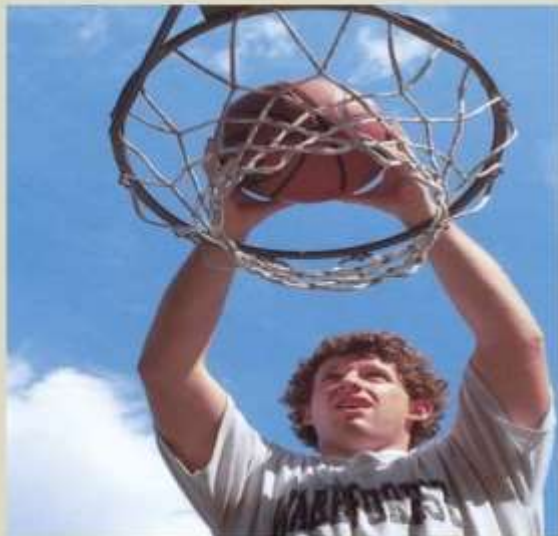
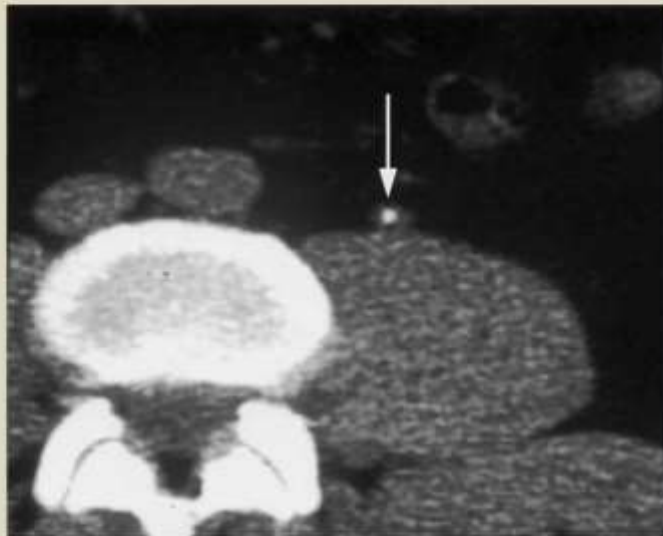
(a) One kind of rim (with thanks to Christopher R. Dyer for his assistance with this photograph.) (b) CT scan shows a thin soft-tissue rim (arrow) surrounding a stone impacted in the middle of the left ureter. The rim represents edema of the ureteral wall. The presence of a tissue rim sign allows a confident diagnosis of a stone within the ureter.

The **soft-tissue rim sign** is used to distinguish a **ureteric calculus** from a **phlebolith**. The former appears as a calcific density with a surrounding rim of soft tissue which represents the oedematous ureteric wall. Phleboliths on the other hand usually have imperceptible walls (although up to 8% may have a soft tissue rim sign) but may have a **comet-tail sign**.

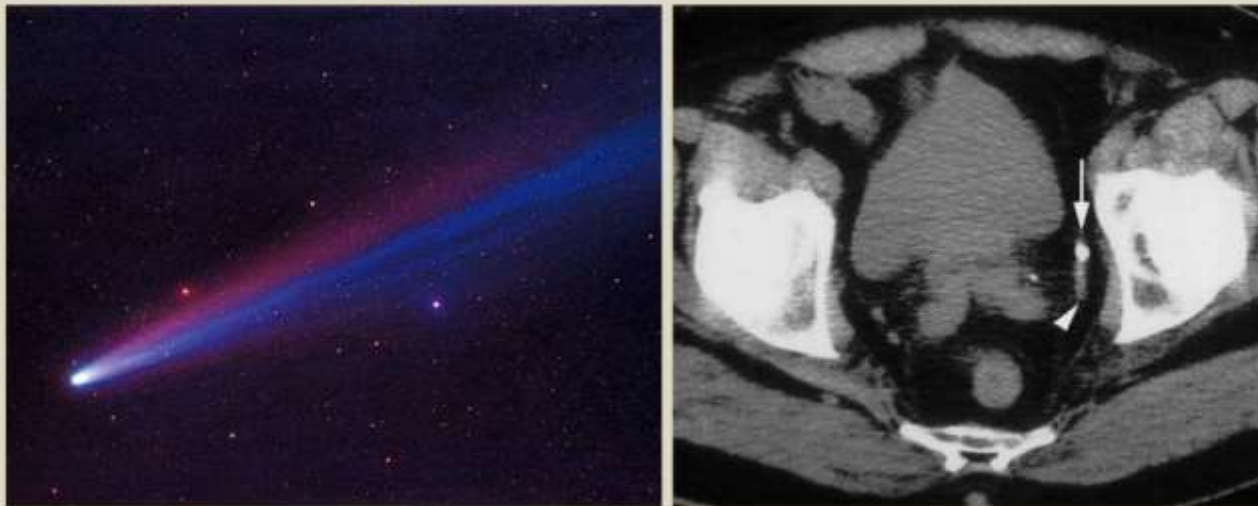
(a) Comet. (Photograph entitled "Comet Hyakutake" reprinted with permission from Bill and Sally Fletcher.) (b) CT scan shows a calcification (the comet nucleus) (arrow) with a soft-tissue tail that represents a pelvic vein (arrowhead). Together, this appearance constitutes the comet sign. Note the stone at the left ureterovesical junction.

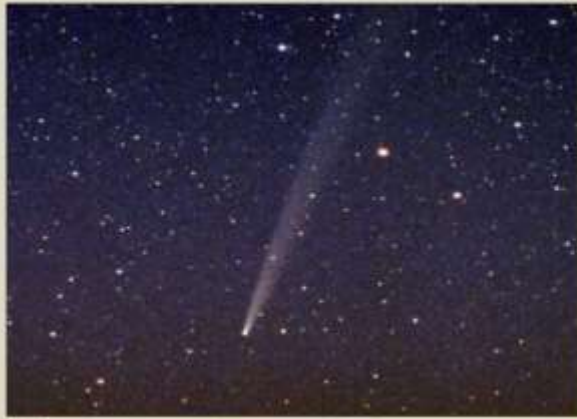
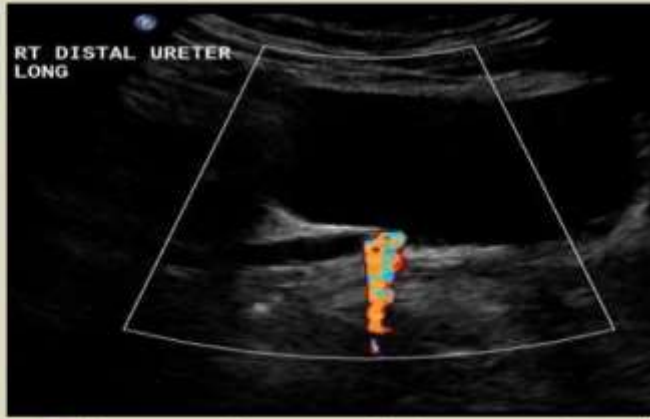
Twinkle and Colour comet-tail artefact.

The colour comet-tail artefact is an ultrasonographic signs seen in a number of situation with color Doppler scanning is performed, Typically the artefact, which resembles the grey-scale comet-tail artefact, is seen in situation when a small highly refractive (usually calcific) object is interrogated with colour Doppler. Twinkle artefact occurs and immediately deep to the object a tail linear aliased band of colour extends away from the probe. small renal or ureteric calculi.

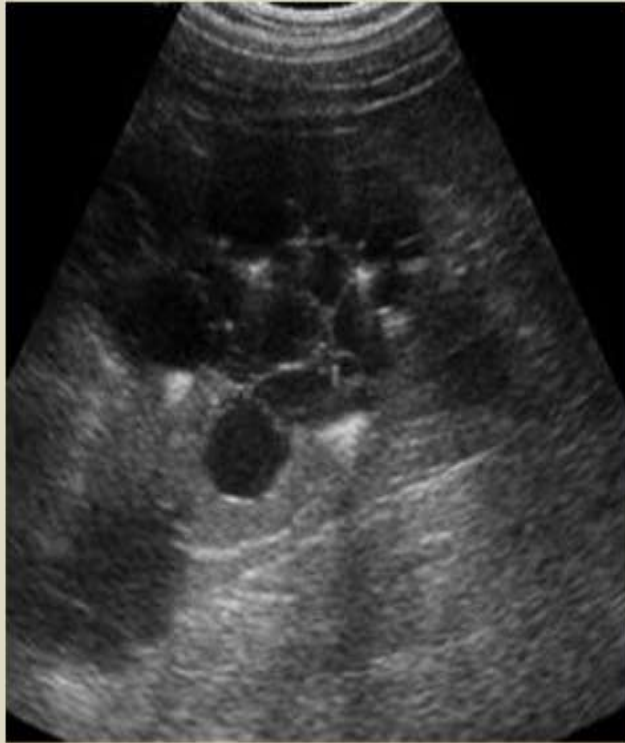
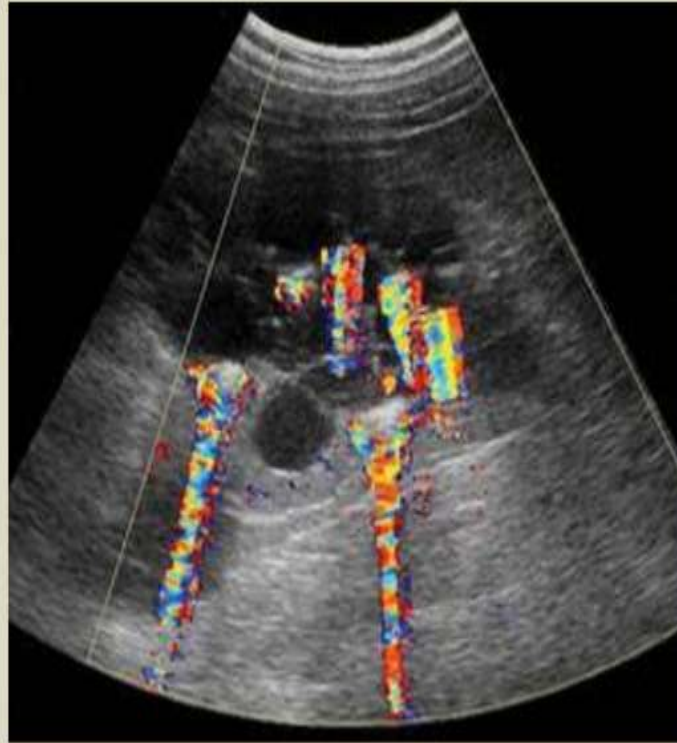
Polycystic kidney disease. Sagittal sonograms with color display off (A) and on (B) display evidence of color comet-tail artifact from calcified wall cysts.

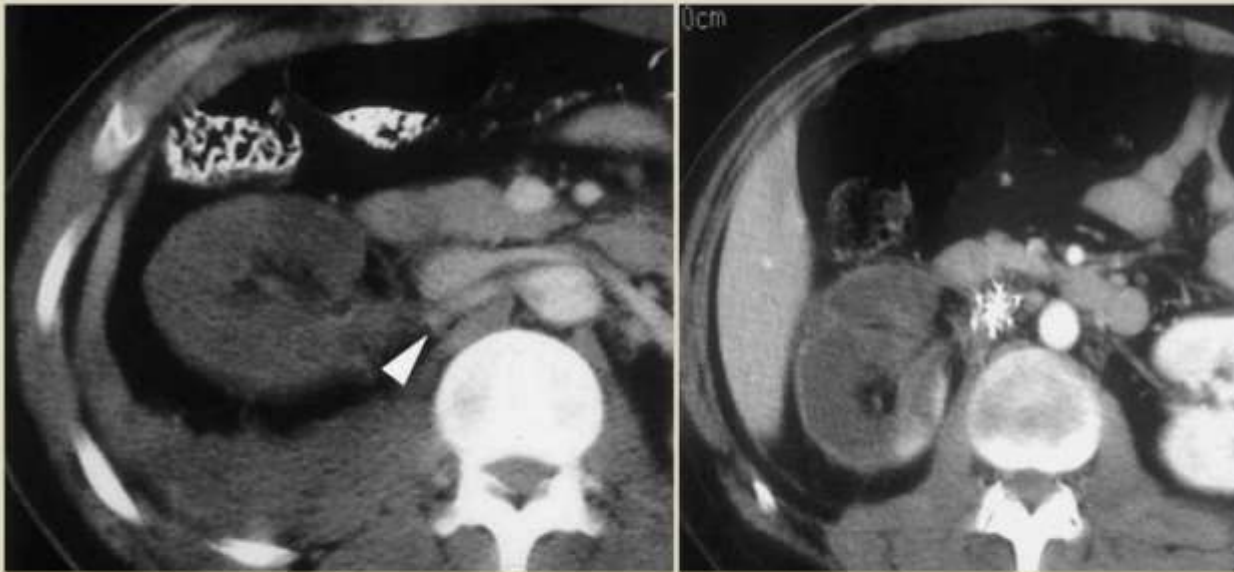
Rim sign of vascular compromise. (a) Enhanced CT scan of a motor vehicle accident victim demonstrates no perfusion in the majority of the right kidney. The right renal artery abruptly terminates; this is the arterial cut-off sign (arrowhead). (b) Repeat contrast-enhanced CT scan, obtained 72 hours after a, demonstrates a thin marginal rim of preserved subcapsular enhancement in the left kidney, typical of the rim sign of renovascular compromise. Vascular compromise in this case was caused by intimal injury and thrombosis of the main renal artery.

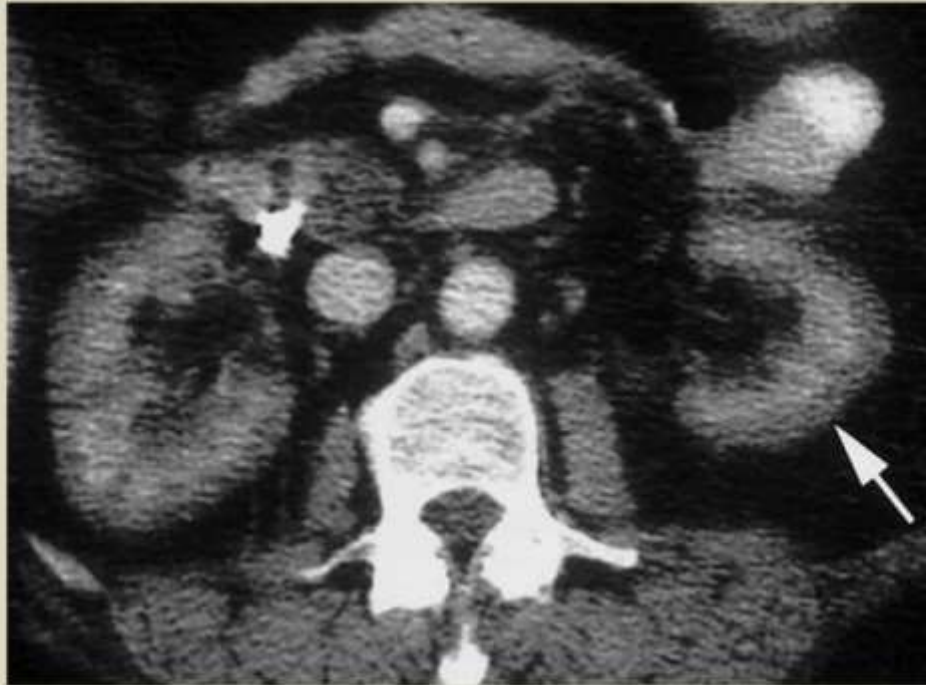
A reverse rim. CT scan, obtained to exclude a large retroperitoneal hematoma in a patient with sustained hypotension for 1 hour after cardiac catheterization and subsequent cardiac arrest, shows a hypoattenuating renal cortex (arrow) compared with the medullary enhancement. No additional contrast material was given after the catheterization. The patient rapidly developed multiorgan failure that led to her death.

The reverse rim sign refers to a hypoattenuating renal cortex visualized at CT, seen against a background of intact medullary perfusion after contrast material is given. This sign also implies severe derangement of cortical blood flow with development of cortical necrosis.

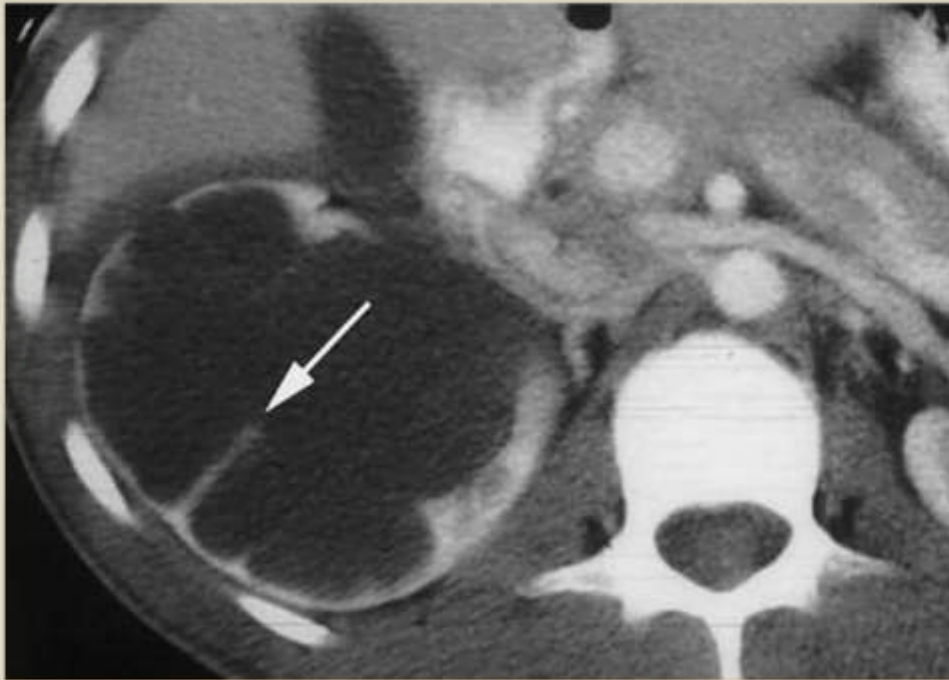
Hydronephrotic rim. CT scan, obtained in a patient with hematuria after minimal trauma, reveals a rim of enhancement surrounding a markedly dilated right renal pelvis and collecting system, findings consistent with congenital ureteropelvic junction obstruction. Note the variable thickness of the enhancing tissue rim (in contrast to the rim sign of vascular compromise [cf Fig 10]), as well as enhancement within cortical columns (arrow).

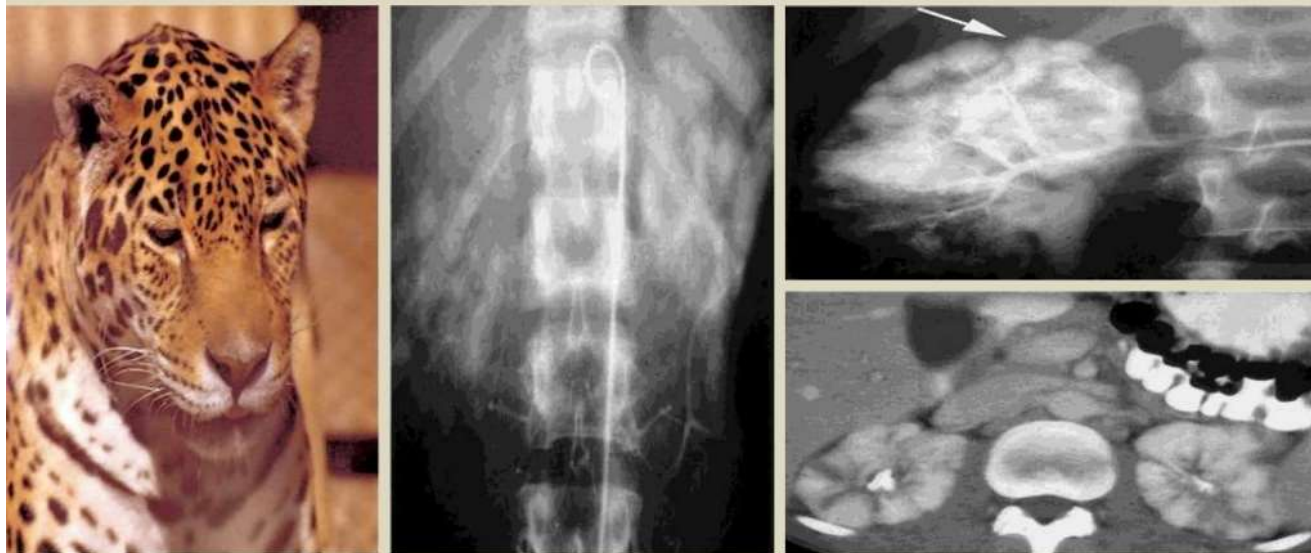
Spotted nephrogram. (13a) Spotted cat. (Courtesy of Russell I. Poole, Mishawaka, Ind.) (13b) Late image from midstream aortography demonstrates patchy perfusion in both kidneys, giving the parenchyma a spotted appearance: the spotted nephrogram. (13c) Late image from selective right renal arteriography in the same patient demonstrates small vessel occlusion and multiple areas of parenchymal infarction (arrow) with islands of preserved perfusion. The patient proved to have periarteritis nodosa. (14) CT scan of another patient with periarteritis nodosa demonstrates the CT correlate of the angiographic findings, with patchy perfusion of the kidneys caused by multiple areas of infarction

Spotted Nephrogram Irregular, patchy enhancement in the renal parenchyma, referred to as the spotted nephrogram, may occur as a result of small vessel occlusion, which can be seen with necrotizing vasculitis (periarteritis nodosa), scleroderma, and hypertensive nephrosclerosis. Although first observed on angiograms, the abnormal perfusion pattern can be identified on CT and MR images after contrast material administration

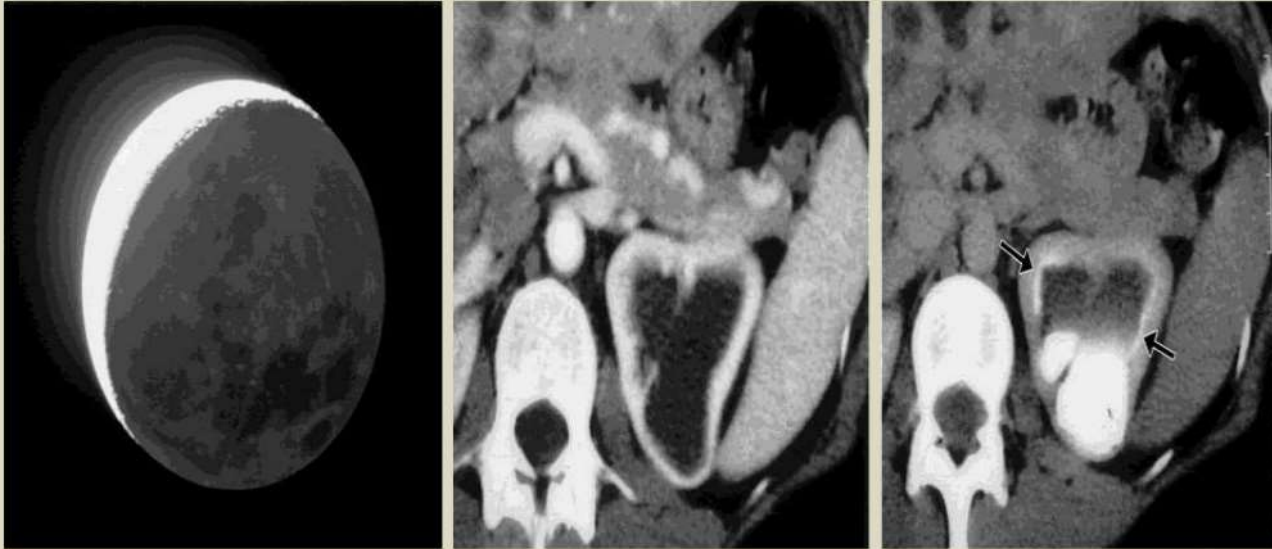
(a) Crescent. (Photograph entitled "Moon with Earthshine" reprinted with permission from Bill and Sally Fletcher.) (b) Crescent sign. CT image obtained during the corticomedullary phase of enhancement shows decreased thickness of the parenchyma surrounding the dilated collecting system in the left kidney. (c) Concentrated contrast material crescents surround the dilated collecting system elements (arrows) on this delayed image, which also shows a urine-contrast agent level in the dependent aspect.

Crescent Sign This sign is fundamentally different in its pathophysiology from the rim sign of hydronephrosis. The crescent sign refers to the appearance of concentrated contrast material in collecting tubules, arranged parallel to the margin of a dilated calyx, which produces a thin line of contrast material at the edge of the calices, resembling a crescent

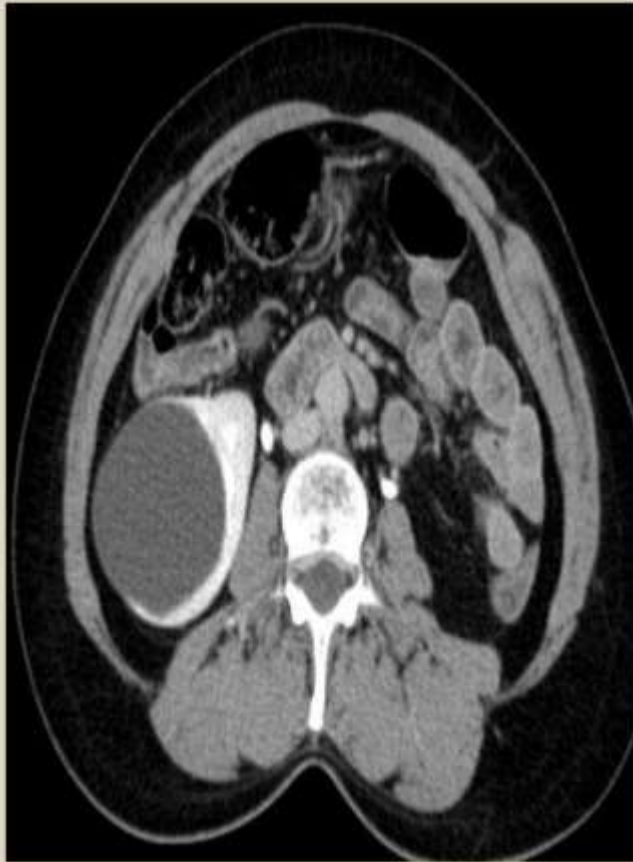
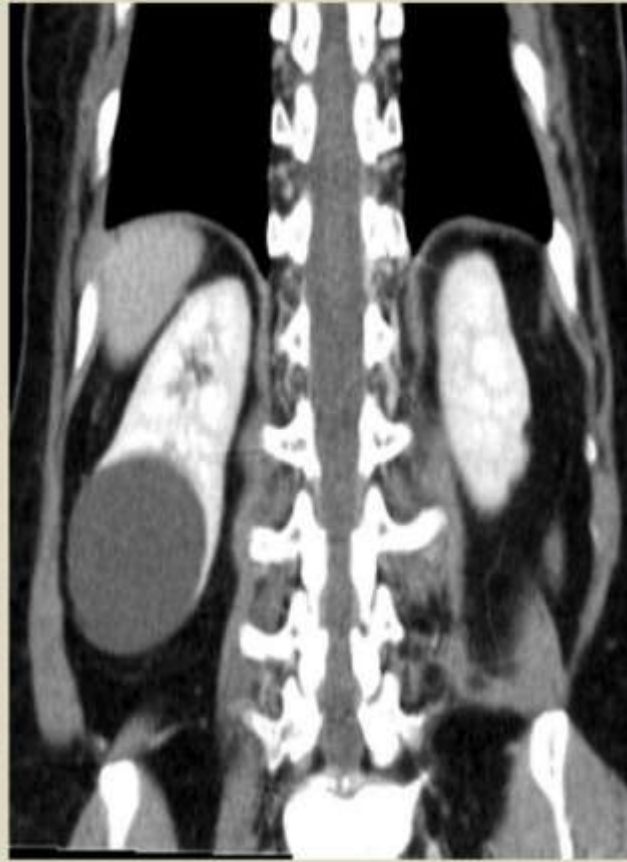
Bosniak 1 renal cyst with crescent sign.
